# Manhole Inspection Summary

Manhole # S31WW\_013MH

Insp Date: **8/27/08 11:33 AM**

**Location** Address: **3122 REMINGTON AVE**

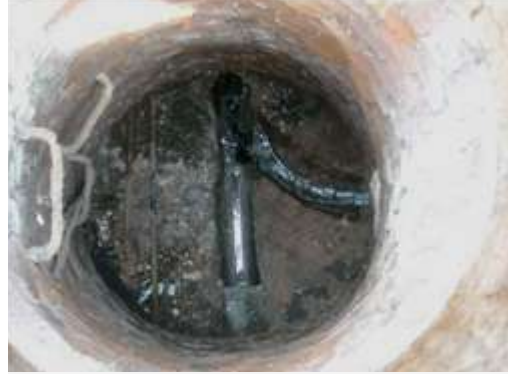
Top View

Corroded steps. Evidence of surcharge - Bench debris.

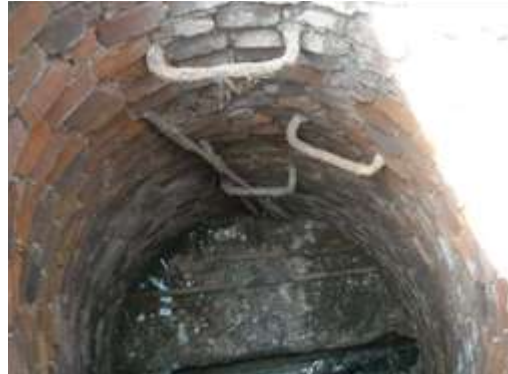
Defect

Condition: ☐ Sound ☐ Cracked ☐ Root Intrusion ☐ Loose Brick ☒ **Deteriorated**

Infiltration: ☐ None ☒ **Joint** ☐ Cracks ☒ **Mortar** ☐ Roots ☐ Wall

Infiltration: ☐ None ☐ Joint ☐ Cracks ☒ **Mortar** ☐ Roots ☐ Wall

Adjustment and Corbel deterioration and infiltration.

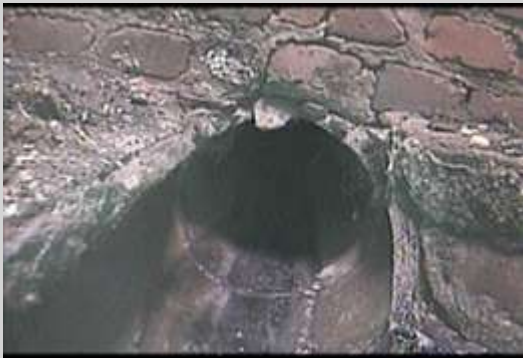
### 8 in. Circular Gravity Sewer Pipe Out @ 12 O'Clock

Barrel deterioration and infiltration.

Infiltration: **Evidence** Pipe Seal Cond: **Broken**

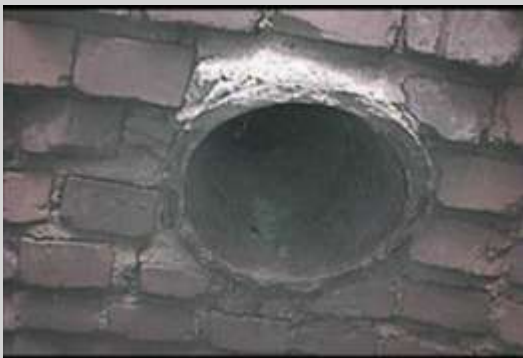
### 8 in. Circular Gravity Sewer Pipe In @ 3 O'Clock

Infiltration: **Evidence** Pipe Seal Cond: **Cracked**

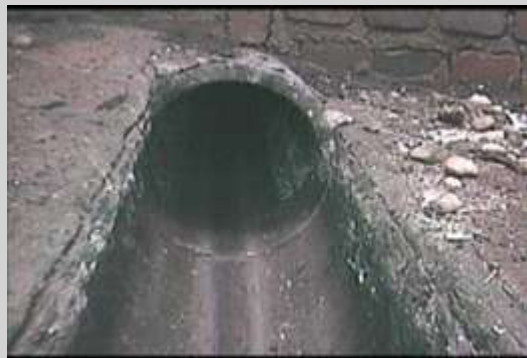
8 in. Circular Gravity Sewer

Infiltration: **Evidence**
